TECHNICAL REPORT ARCCB-TR-01016

**EXPERIENCES AND MODELING OF HYDROGEN
CRACKING IN A THICK-WALLED PRESSURE VESSEL**

**US ARMY ARMAMENT RESEARCH,
DEVELOPMENT AND ENGINEERING CENTER
CLOSE COMBAT ARMAMENTS CENTER
BENÉT LABORATORIES
WATERVLIET, N.Y. 12189-4050**

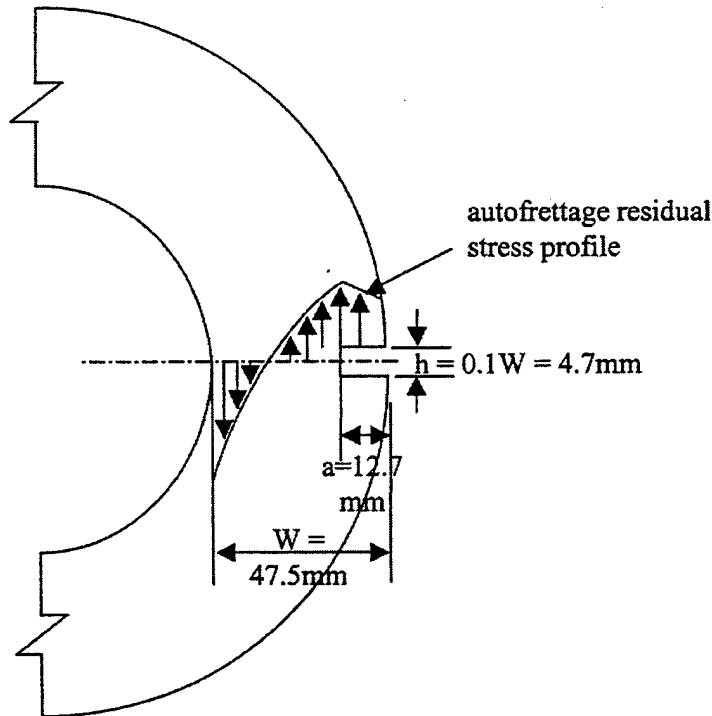
In order to verify previous laboratory hydrogen cracking results on high-strength armament steels (ref 3), a full-scale hydrogen-cracking test on an existing pressure vessel was proposed. A keyway measuring 4.7-mm in width, 12.7-mm in depth, and approximately 450-mm long, with an included radii of 0.4-mm was machined parallel to the axis of the pressure vessel (Figure 1). The pressure vessel, made from A723 Grade 2 steel was heat treated to a nominal 1170 MPa yield strength. The tensile residual stress, at the position in the unnotched pressure vessel wall corresponding to the root of the keyway was +500 MPa, well below the yield strength of the material.

Figure 1. Configuration of pressure vessel with superimposed residual stress distribution.

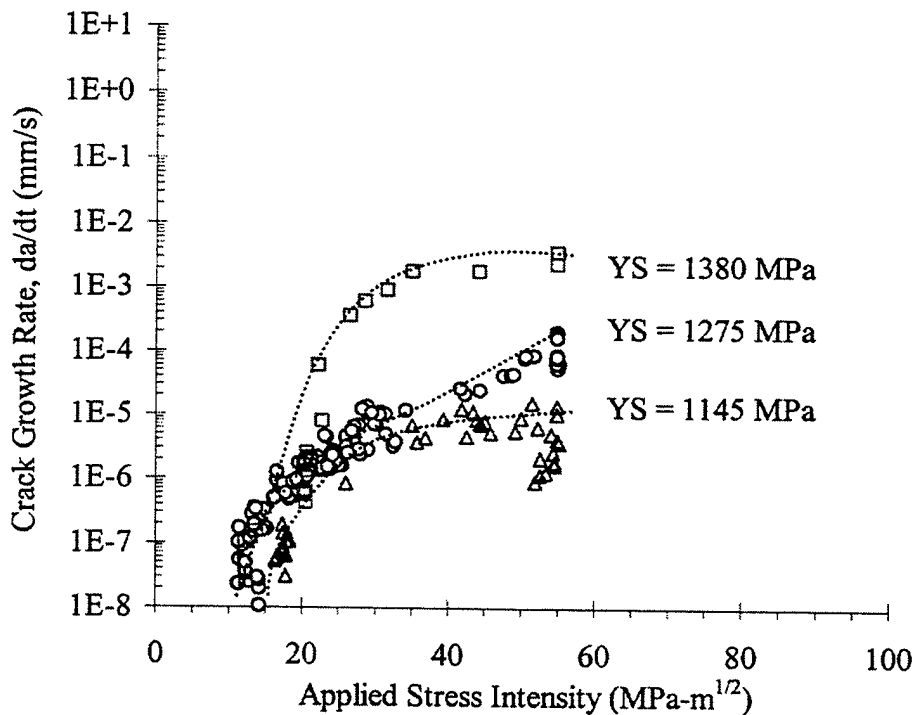
Vigilante et al. (ref 4) have conducted environment testing of A723 steel over a wide range of strength levels ranging from 1145 MPa to 1380 MPa, and using a 50% H₂SO₄/50% H₃PO₄ acid solution as the source for the hydrogen (Figure 2). An applied stress intensity (K_o) of 55 MPa-m^{1/2} was initially applied for all tests. Their tests were conducted with a constant displacement bolt-loaded compact specimen that had previously been fatigue cracked to induce a sharp crack initiation site. Based on their published da/dt versus ΔK data, it was estimated that the pressure vessel would not crack as a result of the sustained +500 MPa residual stress. Several conditions existed that led to this conclusion, namely, Vigilante's results were conducted with sharp fatigue cracks; the stress concentrator in this pressure vessel was much less severe; and the applied stress intensity level was believed to be near the threshold necessary to induce cracking. The prior results showed that 3000 hours of incubation time would be necessary to initiate cracking, however, this particular test was scheduled to be completed after 1500 hours.

Figure 2. da/dt versus ΔK in 50% H₂SO₄/50% H₃PO₄ acid for ASTM A723 steel at three different strength levels.

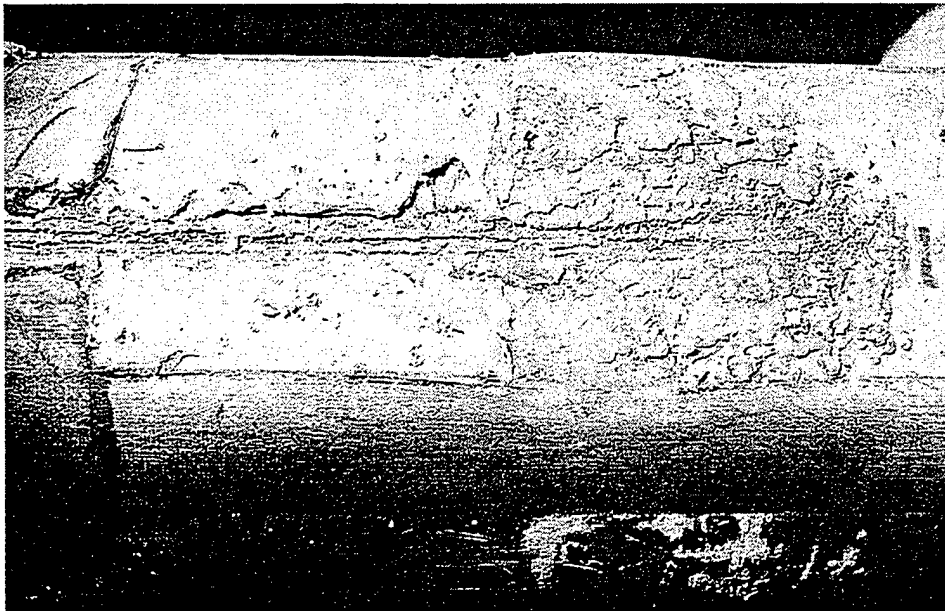
the acid had been depleted and an additional 2 ml of acid was added to the keyway to maintain the initial level of acid in the keyway. During the course of the next 300 hours, the pressure vessel was monitored both visually and with ultrasonics to detect any cracks, yet none were observed. During this time however, the acid had become completely depleted and additional acid was added to restore the initial level of acid in the notch. A white residue (Figure 3) was observed, and is believed to be a by-product of the reaction between the acid and the steel. This residue greatly hindered the inspection process. Over the course of the remaining 1500 hours, the inspections and addition of the acid continued, but no cracking was observed. At this time, the acid was neutralized, and magnetic particle and ultrasonic inspections of the keyway were performed. It was then that a crack-like discontinuity was noticed, however the operator was still unsure as to the extent of the damage. The pressure vessel was subsequently exposed to a single-peak pressure cycle of approximately 300 MPa, and the pressure vessel split open exposing the crack surface (Figure 4).

Figure 3. Corrosion by-product on pressure vessel resulting from acid environment.

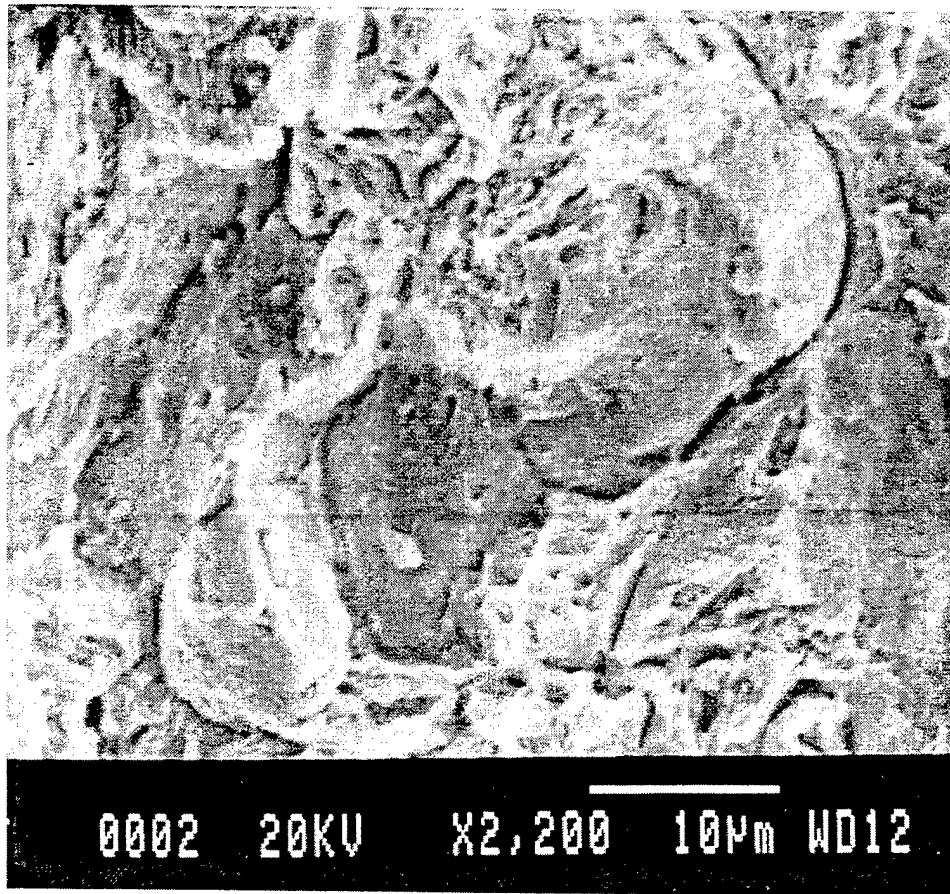
Scanning electron microscopy (SEM) was performed on the fracture surface. The fracture surface was corroded and damaged as a result of the prolonged exposure to the acid environment and the single-cycle mechanical overload. The majority of the fracture surface had been so badly damaged, that the details of the event were "etched" away. As a result of this, no conclusive forensic evidence of the fracture morphology was observed. One area of speculative intergranular fracture can be observed in Figure 5.

Figure 5. Speculative intergranular fracture.

Note in this photomicrograph the occurrence of what appears to be secondary cracking in the grain boundaries. An ASTM grain size calculation was performed, and a grain size of 10.7 was measured. During the SEM investigation, a sharp demarcation line at a crack depth approximately 4-mm below the base of the notch was clearly observed (Figure 6). It was obvious to the naked eye that there was a different fracture appearance in this 4-mm region than on the remainder of the fracture surface. A cross section of the fracture was obtained and a microhardness profile was taken that emanated from the notch toward the inside diameter of the

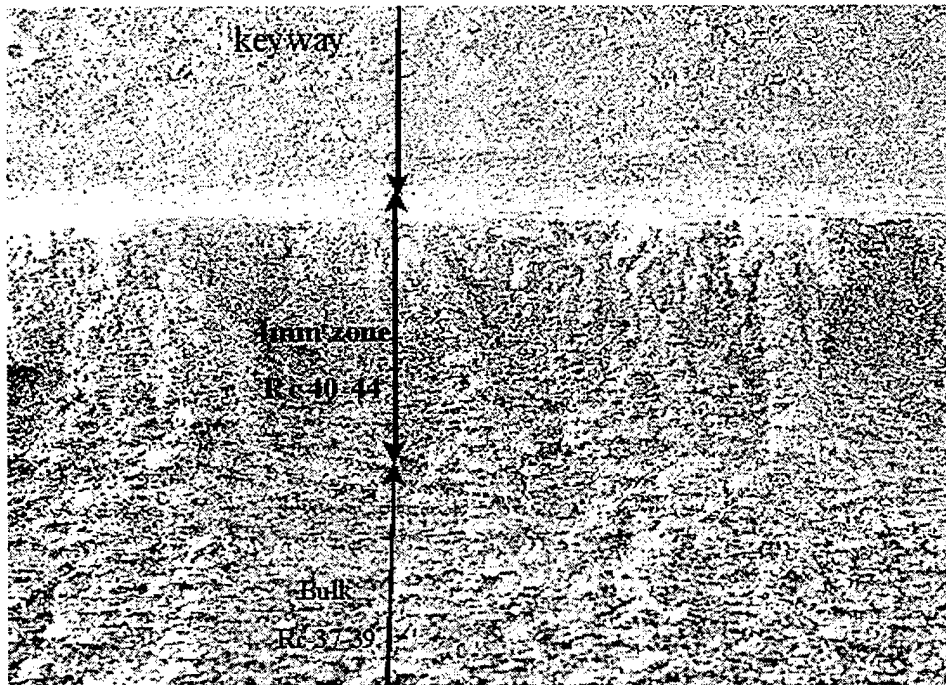
pressure vessel. The microhardness reading showed a progressive gradient of hardness of R_c 44 at the notch surface and a hardness of R_c 40 at a depth 4-mm below the notch. The bulk of the material beyond the 4-mm region possessed a hardness range of R_c 37 to 39. The cause of this localized hardened region is not known.

Figure 6. 4-mm fracture zone.

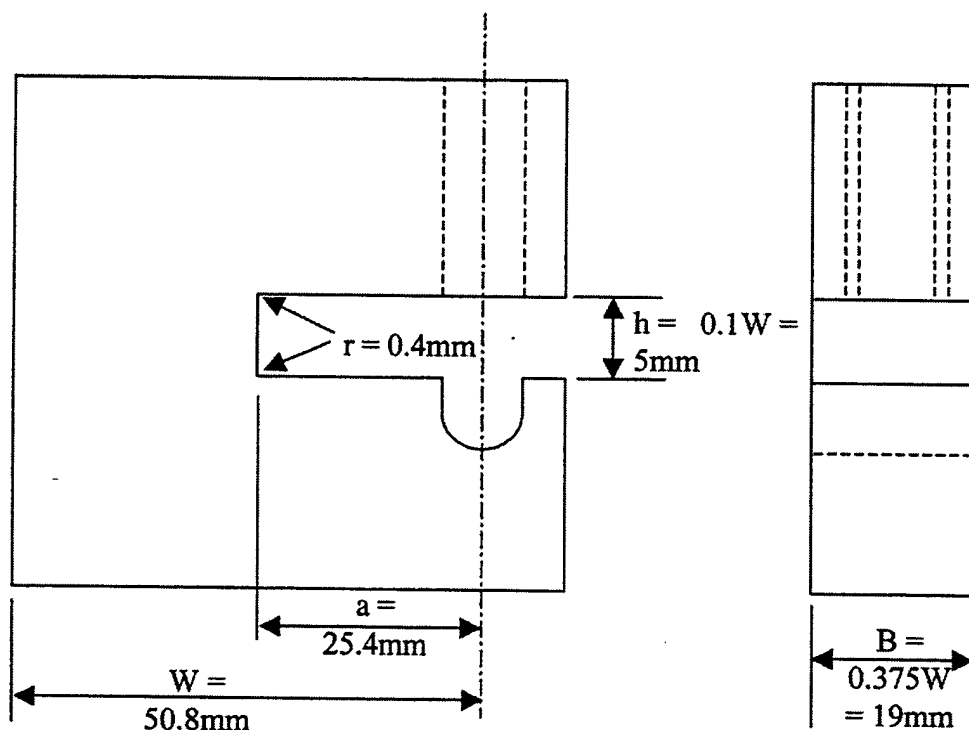
Hydrogen cracking tests were conducted on modified bolt-loaded compact specimens similar to the one used in Reference 2. In these tests, a similar notch detail modeling the pressure vessel was utilized (Figure 7). An instrumented bolt, outfitted with strain gages imbedded within the body of the bolt accurately measured the applied loads. The concept was to model the stress field in the pressure vessel using finite element analysis, and simulate the same stress field in the test specimen. Many of the details in the pressure vessel were modeled, including the similar h , W , and r dimensions. Because of load limitations with the instrumented bolt, a longer notch depth was necessary in order to induce the same stress fields.

Figure 7. Configuration of modified bolt-loaded compact specimen.

After over 300 hours the specimen's exposure to concentrated H_2SO_4 , no cracking was observed. It is believed that different constraint conditions were present in the pressure vessel when compared to the test specimen. The finite element analysis results matched the stress state of the specimen to that of the pressure vessel in the hoop and radial directions, and disregarded the stresses in the axial direction. However, the free surface of the 19-mm thick test specimen resulted in a predominately plane-stress condition, whereas the much larger pressure vessel was predominately plane-strain.

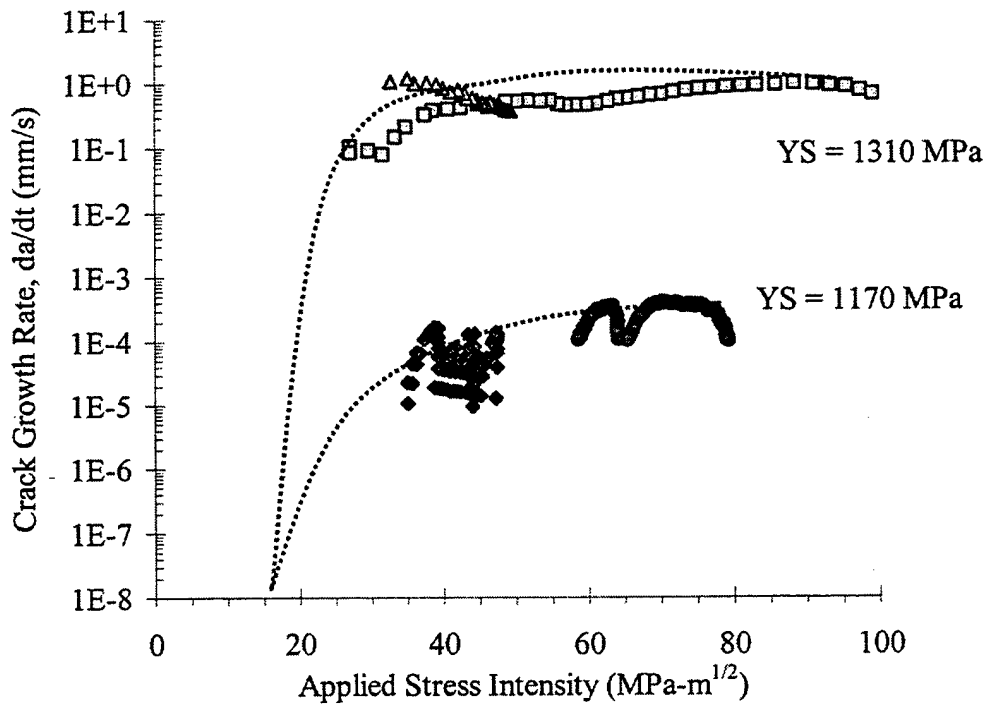
Further testing of the bolt-loaded compact specimen was conducted in order to establish a baseline for hydrogen cracking in concentrated H_2SO_4 . Although it was not known at this time what effect the different acids would have on the crack growth rates, it was speculated that the effects would only be minimally different than those observed with the 50% H_2SO_4 /50% H_3PO_4 . Further testing of 1310 MPa and 1170 MPa yield strength A723 specimens was performed. The 1310 MPa specimens were loaded to a K_o of 100 $\text{MPa}\cdot\text{m}^{1/2}$ and 55 $\text{MPa}\cdot\text{m}^{1/2}$, and the 1170 MPa specimens were loaded to a K_o of 80 $\text{MPa}\cdot\text{m}^{1/2}$ and 50 $\text{MPa}\cdot\text{m}^{1/2}$. The result of these tests can be observed in Figure 8. The results suggest a $K_{I\text{eac}}$ of approximately 17 $\text{MPa}\cdot\text{m}^{1/2}$, approximately the same as that previously observed by Vigilante et al. (ref 4). Note, however, that the crack growth rates are significantly faster in concentrated H_2SO_4 than those tested in the 50% H_2SO_4 /50% H_3PO_4 .

Figure 8. da/dt versus ΔK in concentrated H_2SO_4 for ASTM steel at different strength levels.

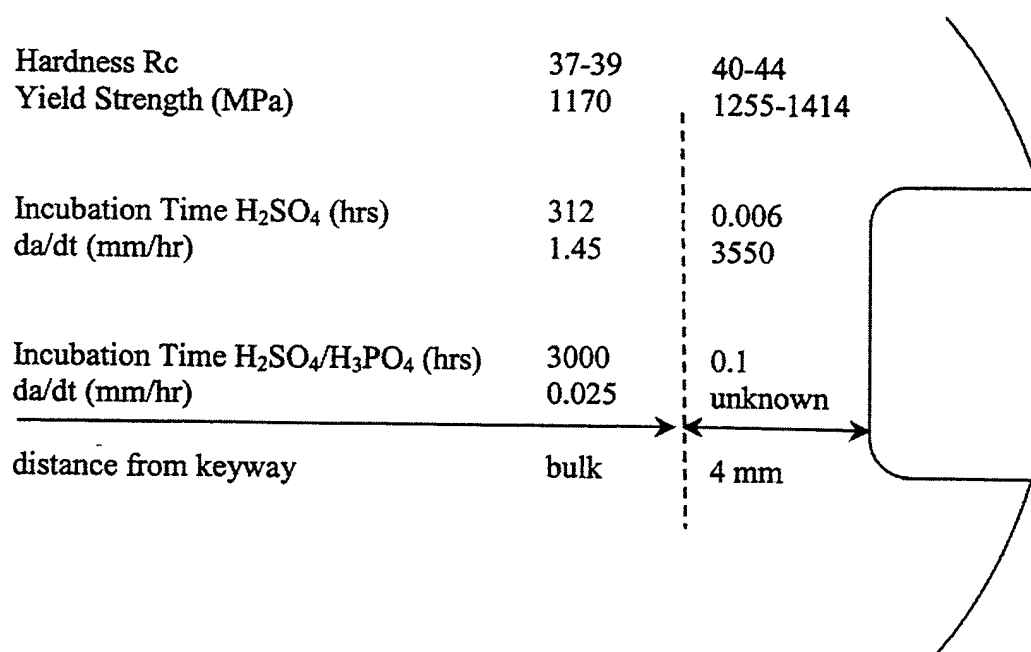
The pertinent test results and environmental cracking data in concentrated H_2SO_4 and 50% H_2SO_4 /50% H_3PO_4 have been compiled in Figure 9. Several scenarios of environmental cracking will be investigated here. The model used is very simple, since we assume that all crack growth that occurs is in the Stage II region. Therefore

The incubation times are simply added into the model by assuming that a dwell occurs between times of crack advancement. The data presented in Figure 9 are for applied stress intensities of 50 to 55 $MPa\cdot m^{1/2}$. This is approximately the same as the $K_{applied}$ of 58.3 $MPa\cdot m^{1/2}$ for the pressure vessel at the point of cracking, which justifies its use in this model.

Figure 9. Schematic of keyway showing key parameters for modeling hydrogen cracking event.

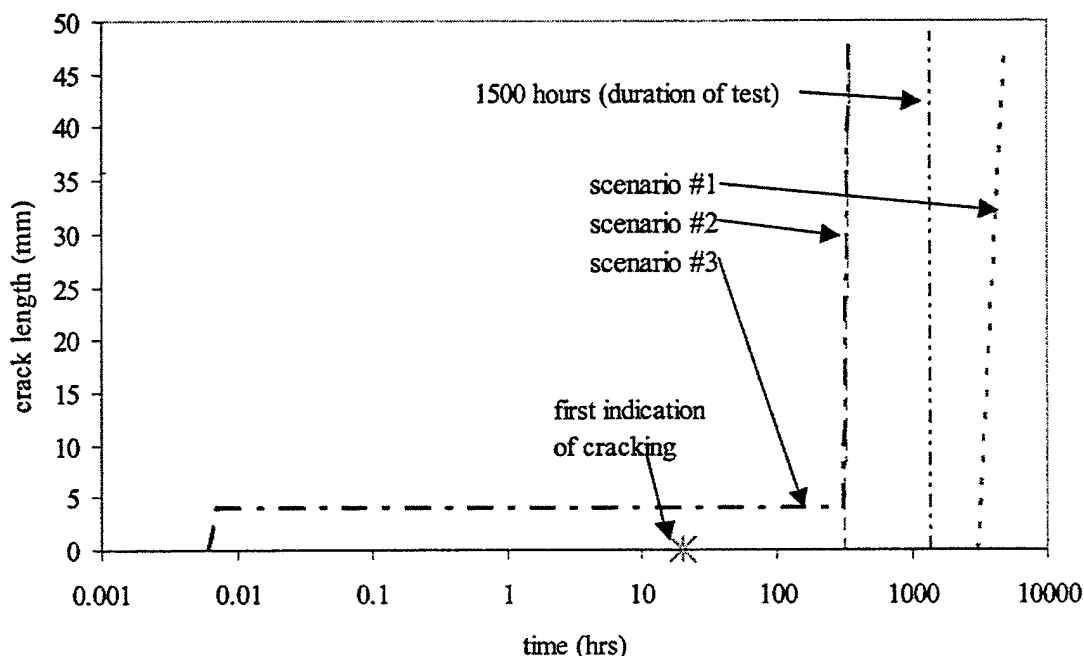
Three different scenarios of environmental cracking are presented and plotted in Figure 10. They are:

Although this scenario did not exist, it does clearly explain the rationale behind our initial belief that cracking would not have occurred under these test conditions. Under this scenario an incubation time of approximately 3000 hours would have occurred, followed by crack advancement to 47-mm (the width of the pressure vessel wall). This scenario is plotted in Figure 9. Note that the predicted crack advancement is beyond the 1500 hours test duration, which validates our initial belief.

Had we simply replaced the 50% H₂SO₄/50% H₃PO₄ with concentrated H₂SO₄, and not had a 4-mm deep hardened layer, it is likely that the cracking would have occurred within the duration of the 1500-hour test. An expected incubation time would be 312 hours followed by crack advancement, nearly through the wall in the next 32 hours of exposure. This scenario, however, does not explain how cracking was observed (associated with depletion of the acid in the keyway) within the first 20 hours of exposure.

In this scenario cracking incubated in 0.006 hour and propagated to a depth of 4-mm in 0.001 hour, when it arrested. The re-incubation into the softer base material took another 312 hours, after which time it propagated nearly through the wall in approximately 30 hours. This scenario clearly suggests how cracking started within the first 20 hours, and how the crack extended nearly through the wall within the 1500 hours of exposure.

Figure 10. Modeling of several hydrogen cracking scenarios.
